Project No.  
**7993.002.024**

Subject: Chateau Development  
Dublin, California

### **GEOLOGIC HAZARD ABATEMENT DISTRICT MONITORING - SPRING 2025**

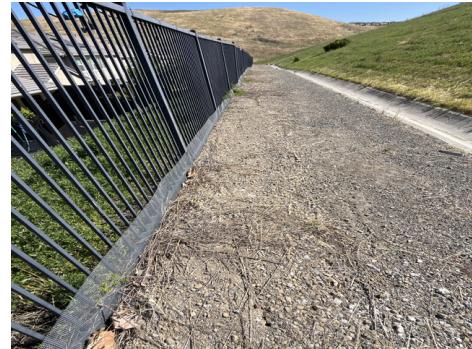
During this monitoring event, distress cracks were observed on the surface of the access roadway directly adjacent to the rear property slope of 3581 Syrah Drive (Site Condition A, Appendix A, Figure 2), and a portion of the rear property fence was tilted in the downslope direction. The distress cracks and tilted fence are an indication of soil creep on the adjacent slope caused by irrigation of the existing slope vegetation/landscaping. Soil creep involves the downslope movement of expansive soil due to wetting and drying of the soil. Fluctuations in moisture regimes of expansive soil may result in movement of soil related to shrinkage and swelling, which can result in an adverse impact to overlying improvements. The GHAD will continue to monitor this condition during future monitoring.

Site Condition: A  
Observation Date: 05/06/2025  
Description: Distress cracking along EVA road surface adjacent to homeowner property slope.  
Recommendation: Continue to monitor.  
Field Representative: GH
