Project No.  
**7993.002.024**

Subject: Chateau Development  
Dublin, California

### **GEOLOGIC HAZARD ABATEMENT DISTRICT MONITORING - SPRING 2025**

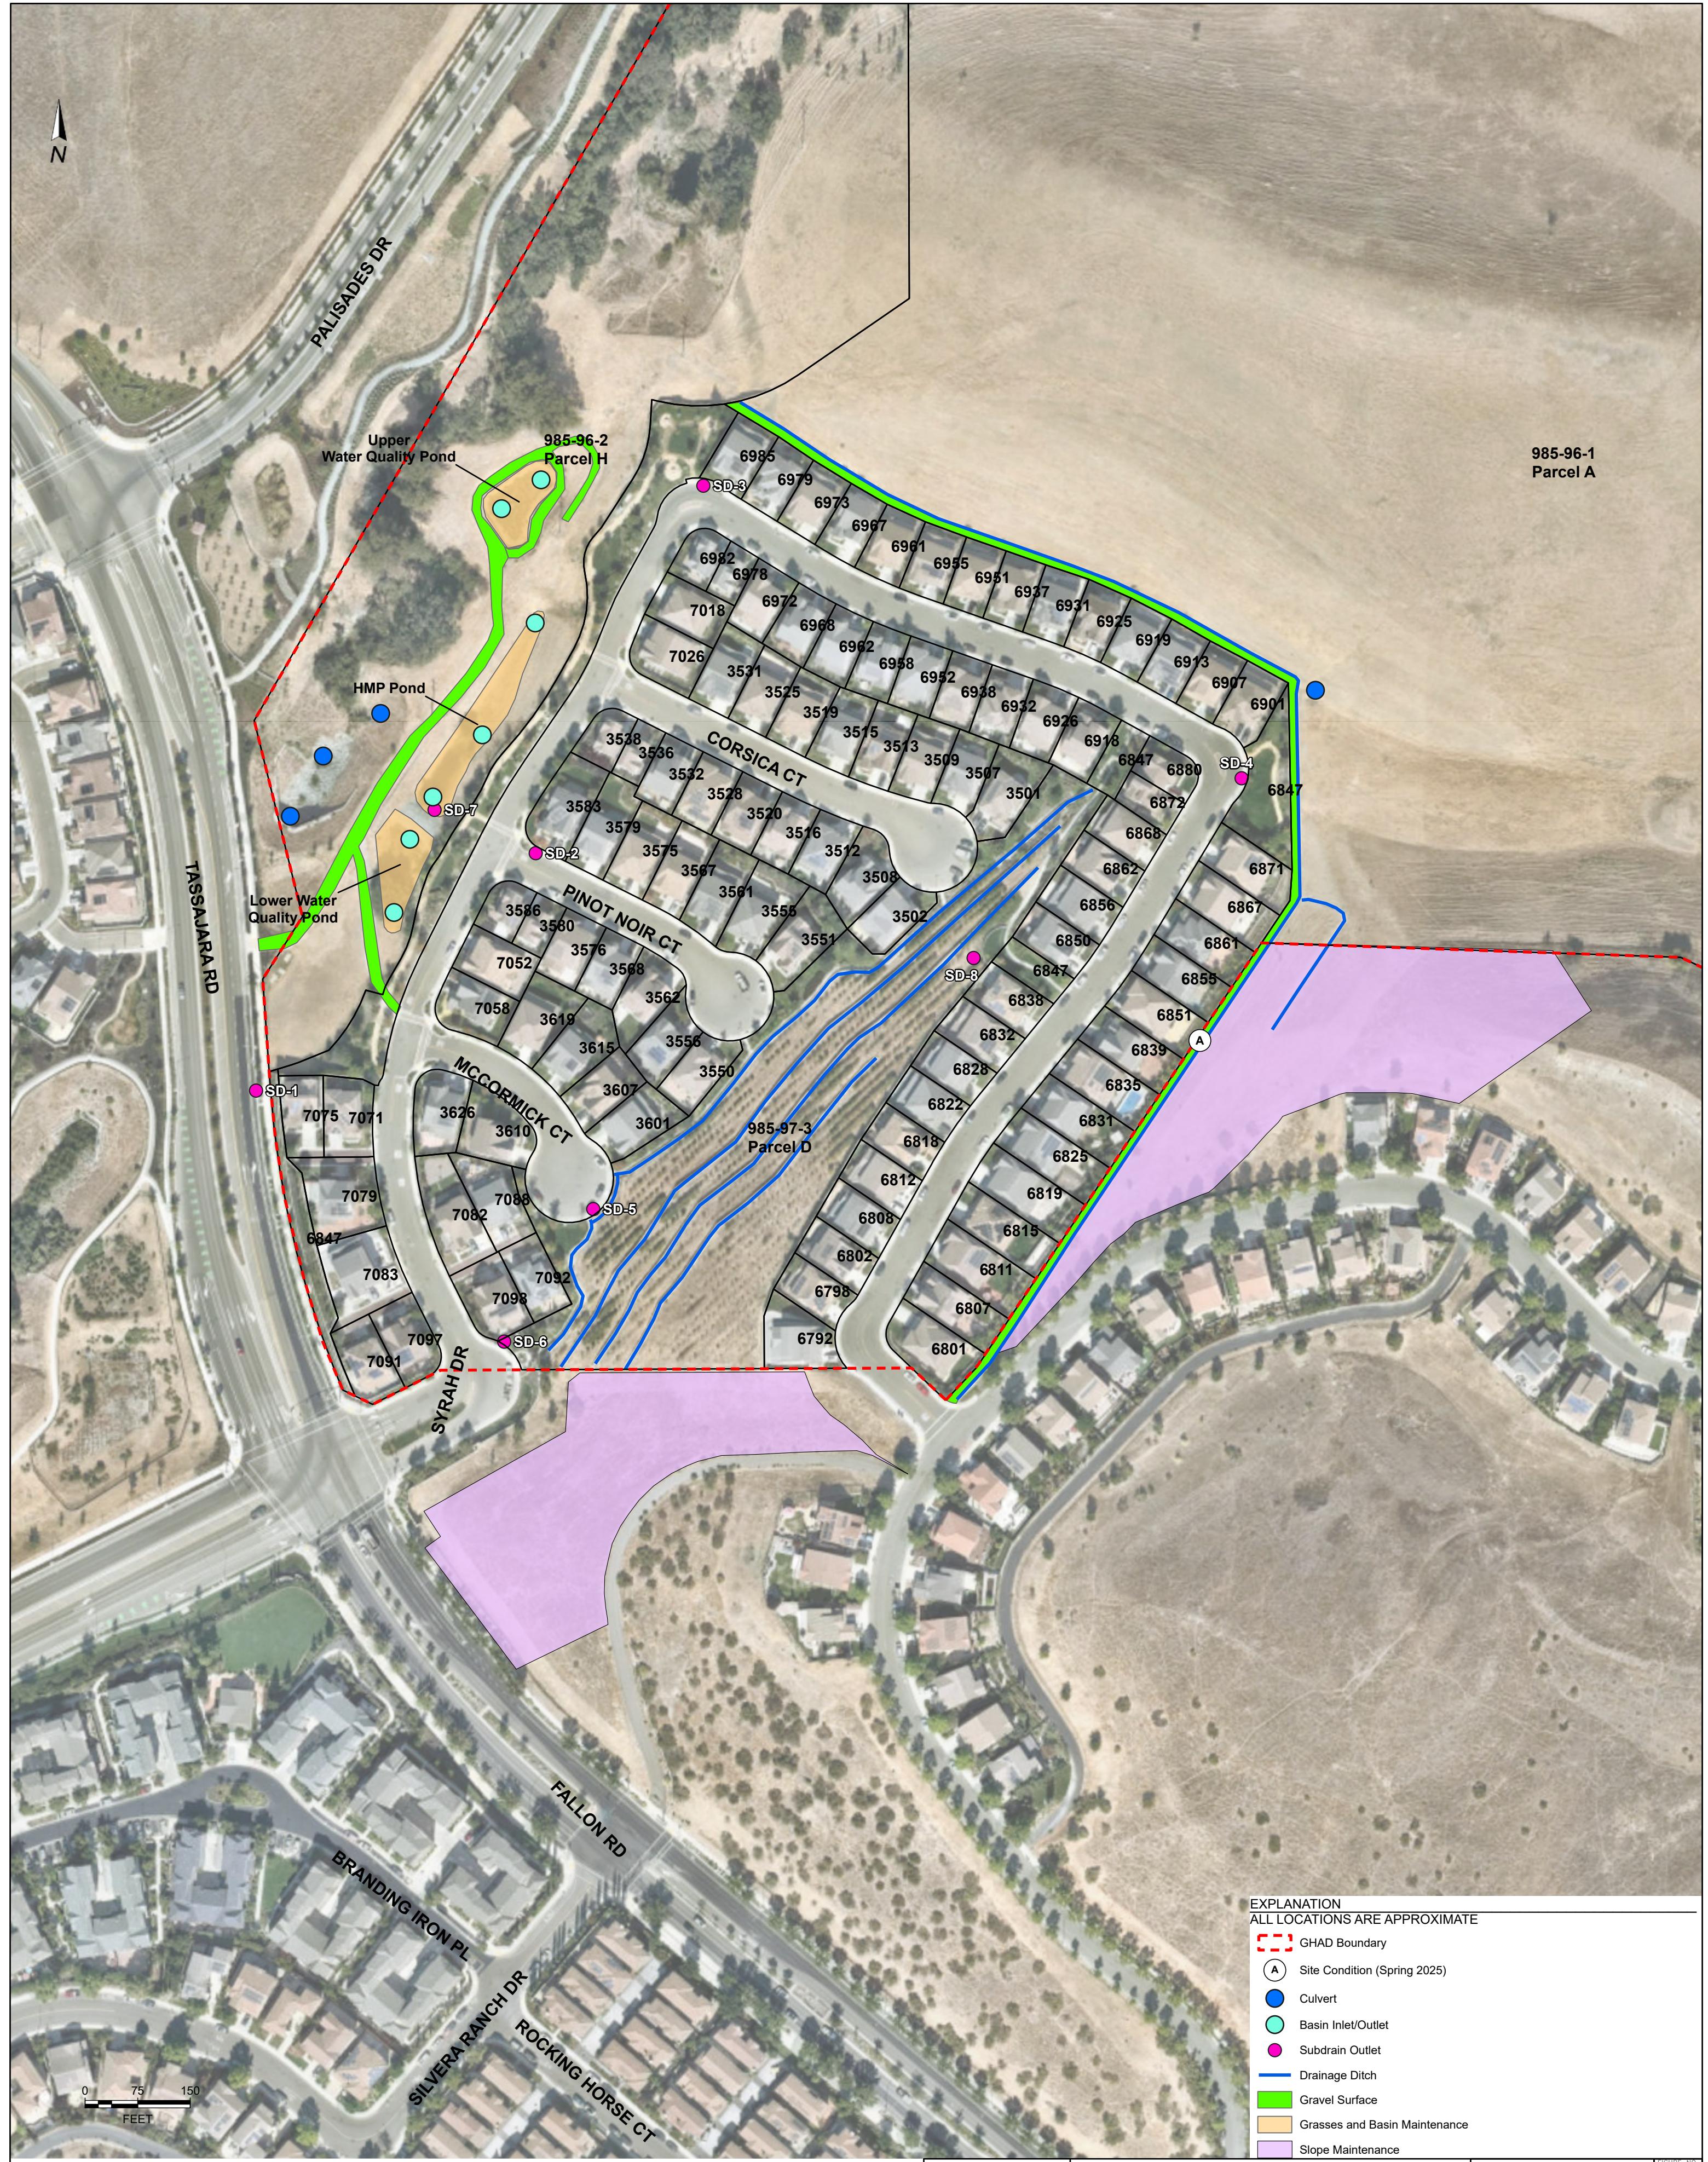
**Figure 2: Site Plan – Chateau Development**

Concrete-lined drainage ditches were checked for accumulation of debris/sediment and for obvious distress, such as cracking or shifting of the concrete. As shown in Figure 2, there are approximately 4,833 linear feet of concrete-lined drainage ditches within the Fallon Crossing GHAD – Chateau Development. As part of the scheduled routine site maintenance, the GHAD removes vegetation, soil, and other unwanted material from the concrete-lined ditches. We observed minor cracks in the concrete ditches. At the time of the site visit, these minor cracks did not appear to compromise the integrity of the concrete-lined drainage ditches and will be repaired, as needed.

Two water quality basins/ponds and one hydromodification basin/pond are located within the boundaries of the Fallon Crossing GHAD – Chateau Development. In the above-referenced Plan of Control, the basins are identified as Upper Water Quality Pond, Lower Water Quality Pond, and Hydromodification Pond (Figure 2). Monitoring of the basins was conducted as part of the open-space monitoring. The observed conditions for the water quality and hydromodification basins are described in the attached monitoring reports.

During this monitoring event, distress cracks were observed on the surface of the access roadway directly adjacent to the rear property slope of 3581 Syrah Drive (Site Condition A, Appendix A, Figure 2), and a portion of the rear property fence was tilted in the downslope direction. The distress cracks and tilted fence are an indication of soil creep on the adjacent slope caused by irrigation of the existing slope vegetation/landscaping. Soil creep involves the downslope movement of expansive soil due to wetting and drying of the soil. Fluctuations in moisture regimes of expansive soil may result in movement of soil related to shrinkage and swelling, which can result in an adverse impact to overlying improvements. The GHAD will continue to monitor this condition during future monitoring.
